**A COMPARISON OF COASTLINE CHANGES ON THE CAUTION REEF ROCKY
AND WLOTZKASBAKEN SANDY SHORES AS A RESULT OF COASTAL EROSION.**

**A Report submitted to the Department Of Fisheries and Aquatic Science, Faculty of
Agriculture and Natural Resources, University of Namibia, in partial fulfillment of the
requirements for the award of the degree of Bachelor of Science in Fisheries and Aquatic
Sciences of the University of Namibia.**

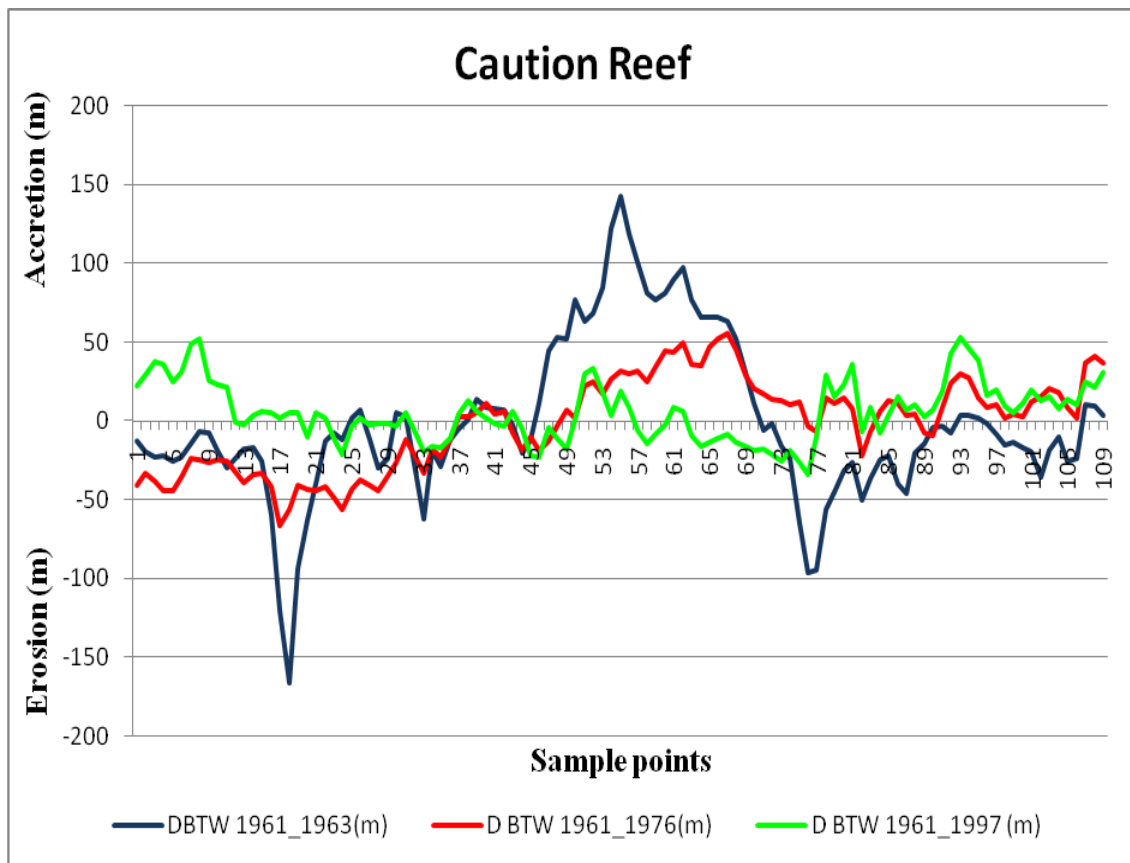
Figure 6: Caution Reef erosion and accretion rates

The highest rate of shoreline accretion, measured to be 4.06m/yr with a seaward displacement of 5.60m, was recorded between 1961 and 1976. This is clearly illustrated in *Figs. 6 and 7* occurring from point 77 to point 80 and from 90 to 96 respectively. The highest rate of erosion was observed during the period 1961-1963, measured at 0.55m/yr with a landward movement of -1.64m. This can be seen from point 30 to 35 in *Fig. 8*.

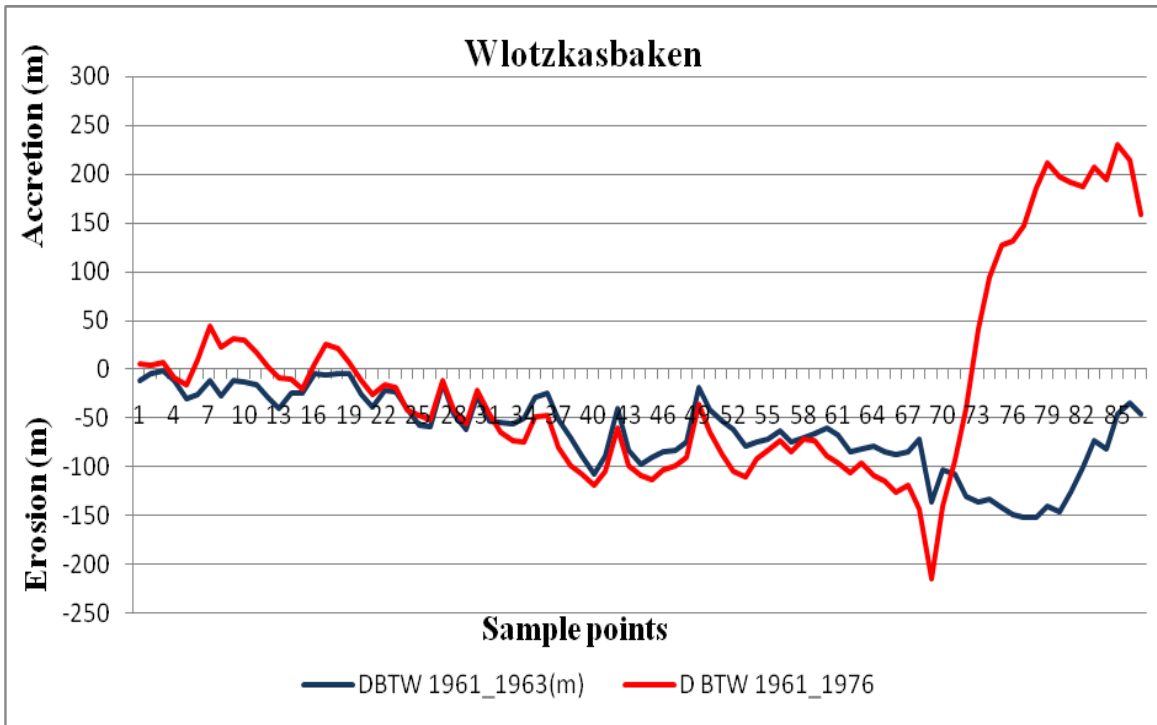
Figure 9: Wlotzkasbaken erosion and accretion rates

The highest rate of shoreline erosion was recorded between the 1961 and 1963 period measured to be 31.41m/yr with a landward displacement of -62.82m. This can be seen occurring from points 34 to 49, (Fig.9 and 10) below. During the 1961-1976 periods, accretion was relatively observed from point 5 to 11 and from point 15 to 18 (Fig.11), with the most prominent accretion occurring from point 74 to 87 (Fig. 9).

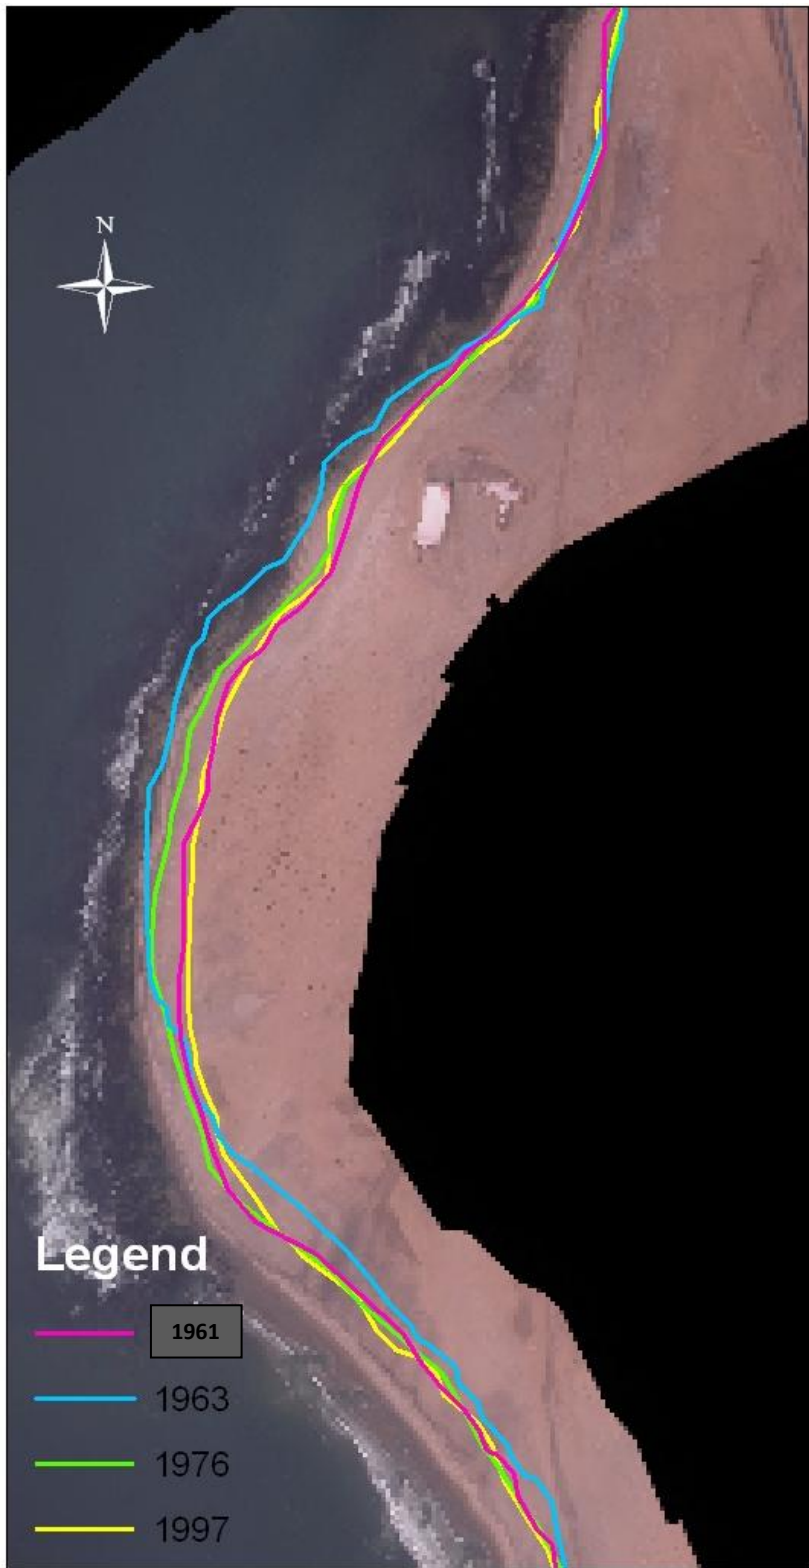
Figure 12: Overall shoreline change at Caution Reef, overlaid on 2003 orthophotograph.

Figs. 12 and 13 below show the overall shoreline change for Caution Reef and Wlotzkasbaken.

The 2003 orthophotograph shows a noticeable headland at both Caution Reef and Wlotzkasbaken. At these headlands, accretion events dominate (Figure 12 and 13). The initial position of the shoreline in 1961 is moved seaward at both areas. These figures also demonstrate the overall stability of the two areas. However, the means for erosion and landward displacement at the two areas show a significant difference ($F_{pr} = \dots < 0.001$).

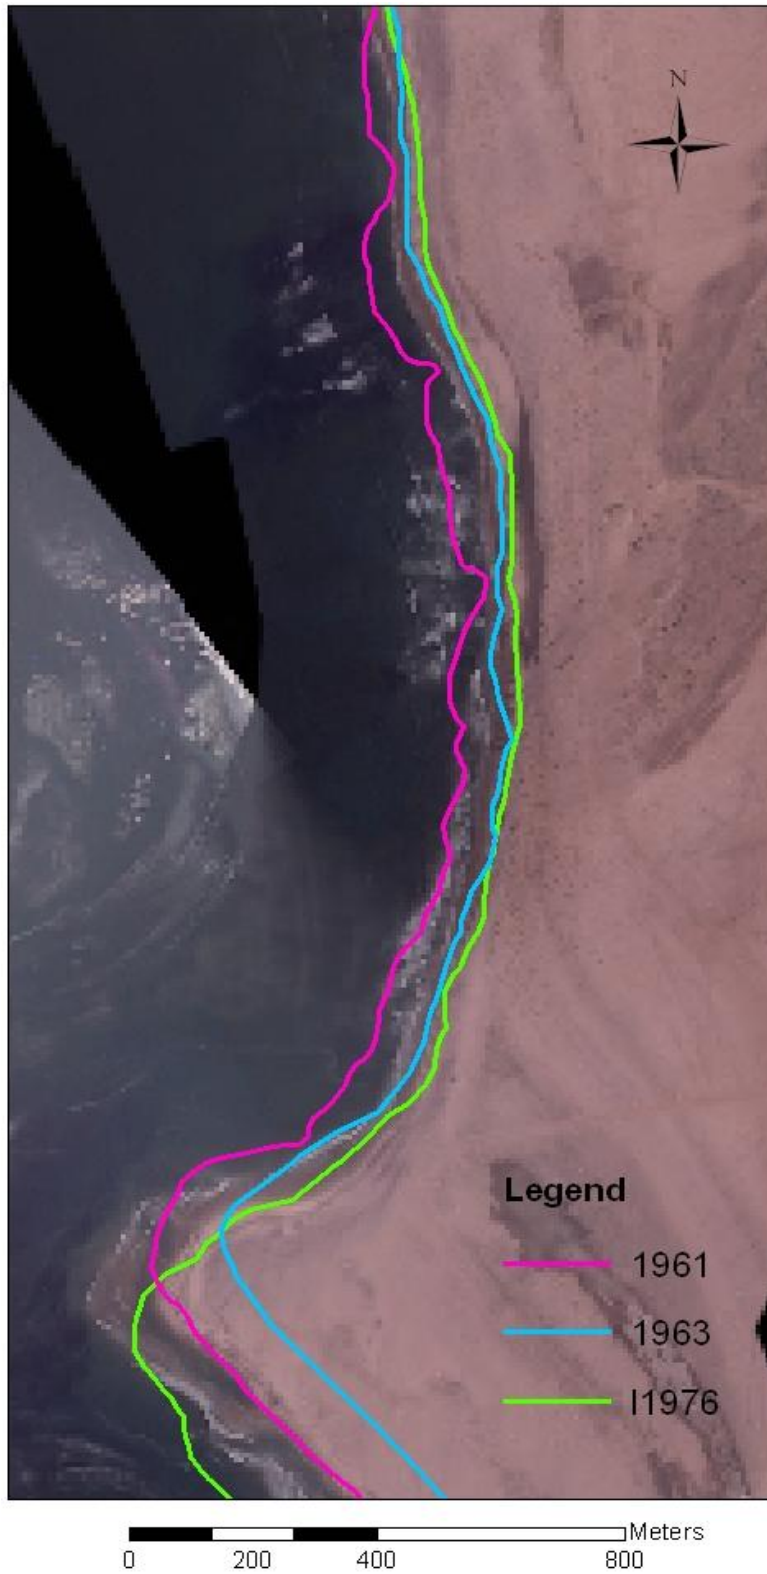
Figure 13: Overall shoreline change at Wlotzkasbaken, overlain on 2003 orthophotograph
